Flood Studies

Overland Flow Path Studies for Goombungee, Pittsworth and Southbrook

November 2015 • *Endorsed on 15 December 2015*

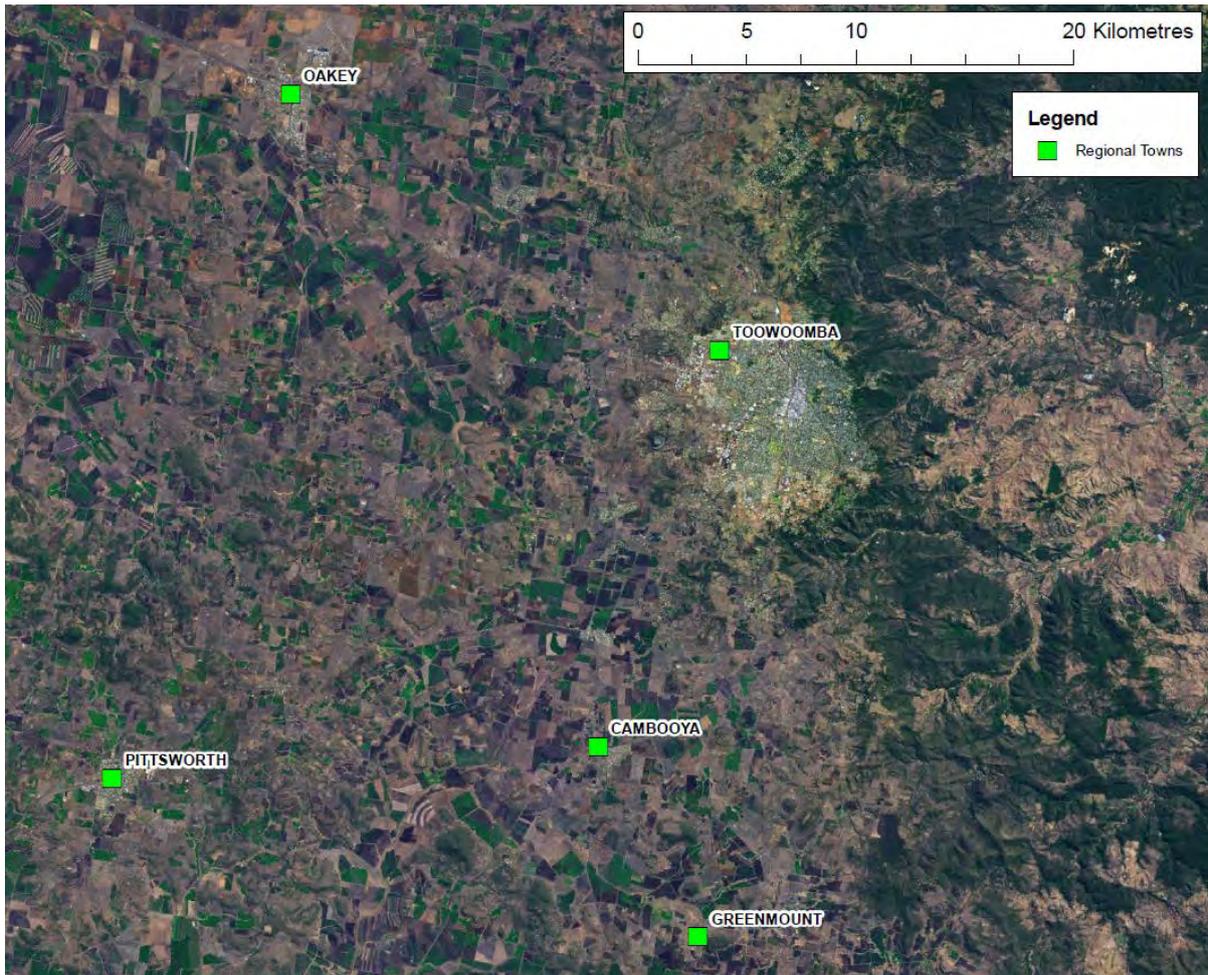
Figure 3.1 Selected Local Rainfall Total Locations for December 2010 and January 2011

of maximum daily totals. The location of the selected rainfall gauges is shown in

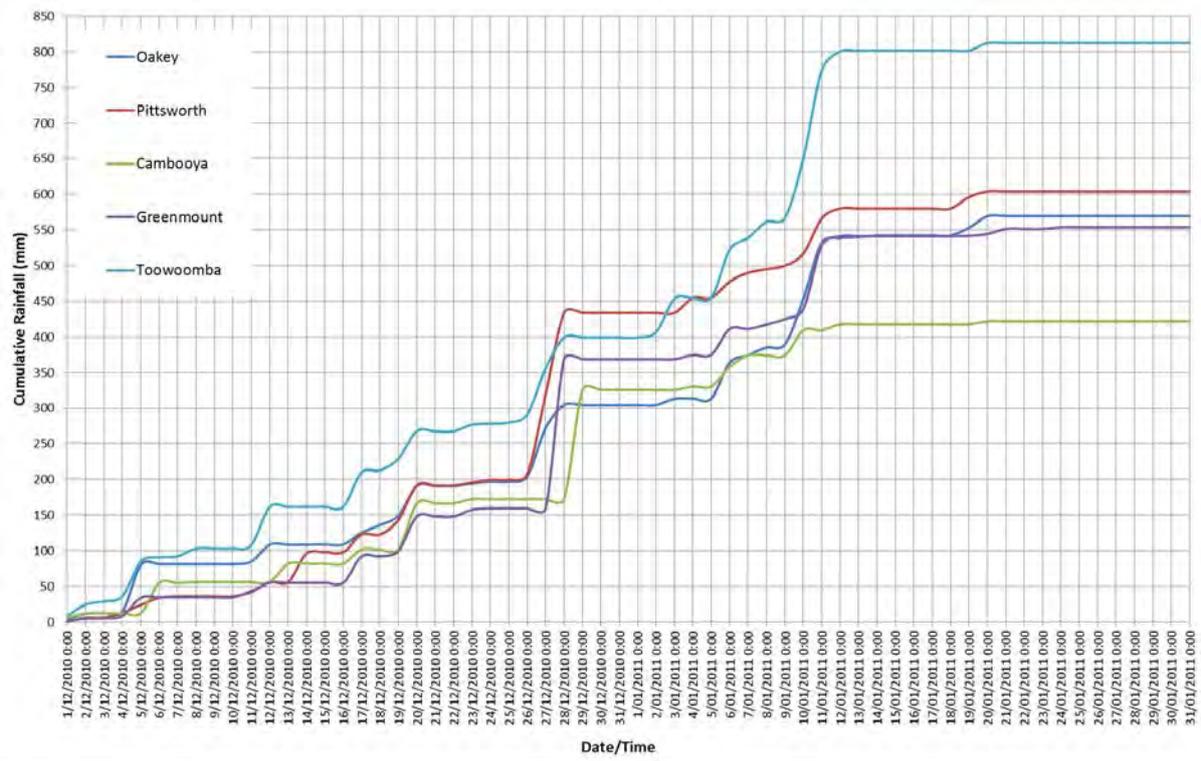
Figure 3.2 Cumulative Rainfall at Selected Locations for December 2010 to January 2011

The following comments are provided in relation to the cumulative rainfall totals at the various gauges presented in Figure 3.2: -

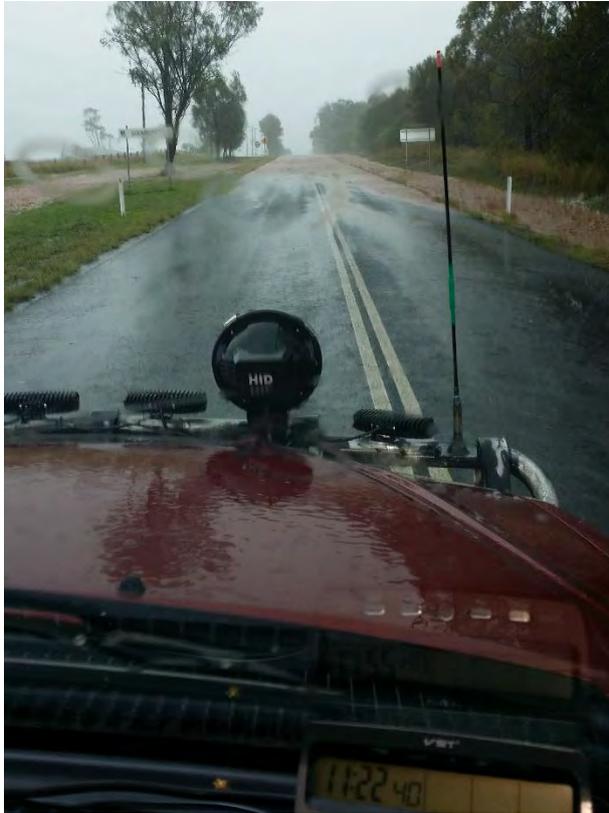
Figure 5.5 Photograph showing inundation of Kingsthorpe – Haden Road, March 2014 (Source: Shane Maxwell)

unless specific landmarks were visible. Figure 5.5 shows inundation of Kingsthorpe-Haden Road during the March 2014 event. The TUFLOW model results exhibit inundation consistent with these locations. A selection of photographs at two unknown locations within the Goombungee Township are shown in Figure 5.6 and Figure 5.7.

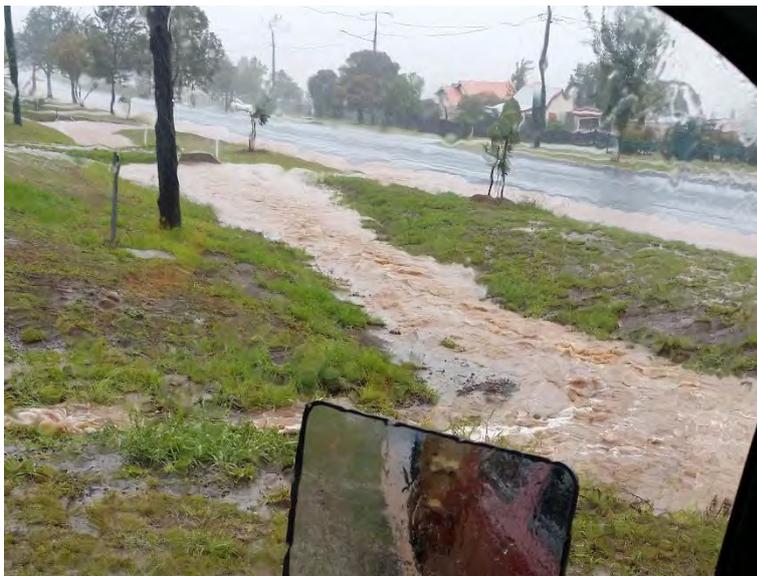
Figure 5.6 Photograph showing inundation of roads in Goombungee, March 2014 (Source: Shane Maxwell)

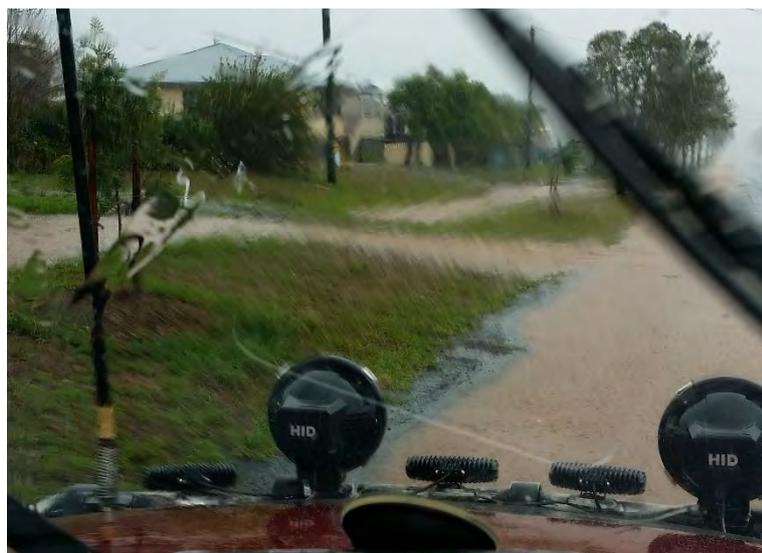
Figure 5.7 Photograph showing overland flooding in Goombungee, March 2014 (Source: Shane Maxwell)

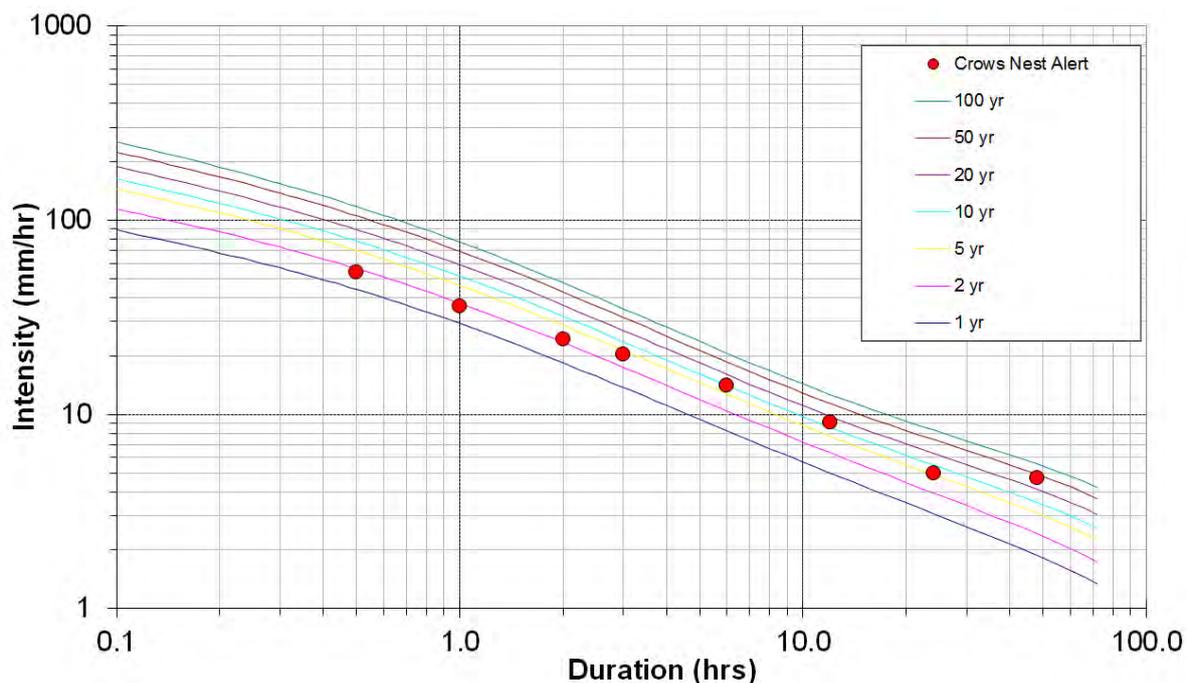
Figure 5.8 Intensity Frequency Duration Curves for Goombungee together with historic rainfall intensities from the Crows Nest gauge for the period 9th to 12th January 2011

While the closest rainfall pluviograph gauge to the Goombungee township is located at Cooby Dam, this gauge was not considered representative of January 2011 rainfall for Goombungee based on the storm direction. Rather, the Crows Nest (gauge ID 540161), some 20 km to the east was selected as being more representative of the January 2011 rainfall. Historical data recorded at the Crows Nest gauge for the period 9th to the 12th January 2011 has been sourced and used to undertake a rainfall frequency analysis which has subsequently been adopted as being representative for the Goombungee Township. Figure 5.8 shows the rainfall data intensity for the event against the Intensity-Frequency-Duration (IFD) data in accordance with Australian Rainfall and Runoff (IEAust, 1998). For shorter duration events up to approximately 5 hours, the event rainfall intensities varied between a 2 and 5 year ARI equivalency. It is noted that the ARI of the historical rainfall was generally equal to a 10 year ARI for durations exceeding 5 hours. The historical rainfall was also found to be up to a 50 year ARI for the longer 48 hour duration event. A similar result was also found to occur based on the same analysis using historical rainfall records for the same event at the Oakey gauge (ID 041359), located 20km to the south of Goombungee.

The results from the hydraulic model validation undertaken for the Goombungee study area found that the observed January 2011 flood levels were on average around 200 mm below the predicted 100 year ARI design event flood levels.

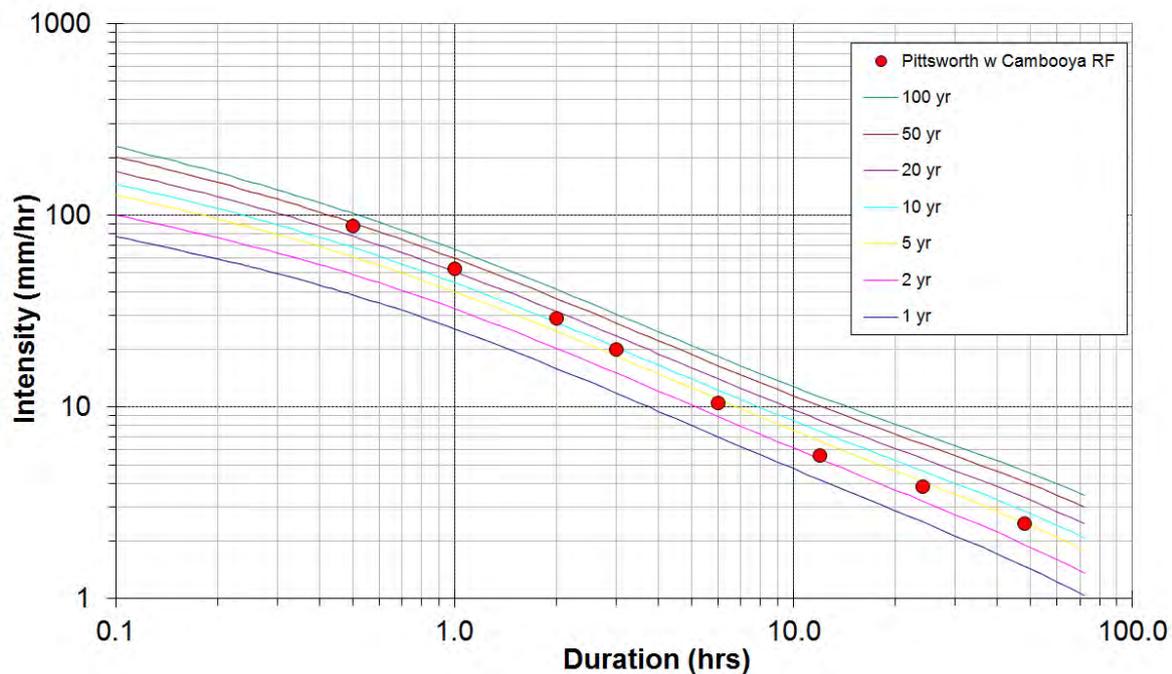
Figure 5.9 Intensity Frequency Duration Curves for Pittsworth together with historic rainfall intensities from the Cambooya gauge for the period 9th to 12th January 2011

duration events up to approximately 1 hours, the event rainfall intensities were in the order of a 20 to 50 year ARI equivalency, depending on duration. Historical rainfall was found to be generally equal to a 5 year ARI for longer durations exceeding 1 hours.

The results from the hydraulic model calibration undertaken at both Pittsworth and Southbrook found that the historical flood records (some of which were January 2011 flood levels) were equivalent to approximately a 100 year ARI design flood event.

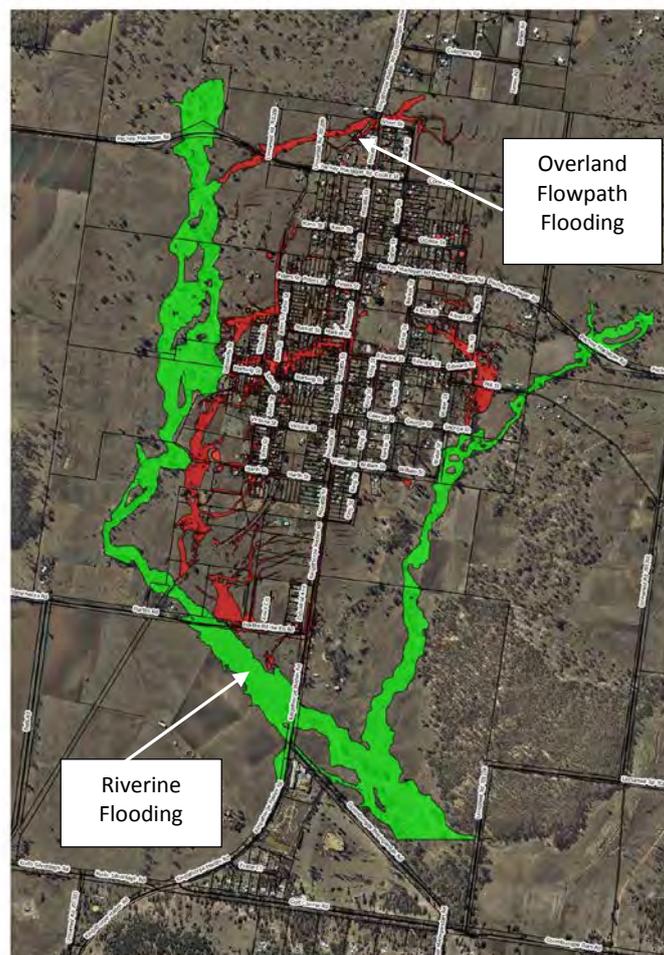
Figure 6.1 Separation of Riverine and Overland Flowpaths, Goombungee

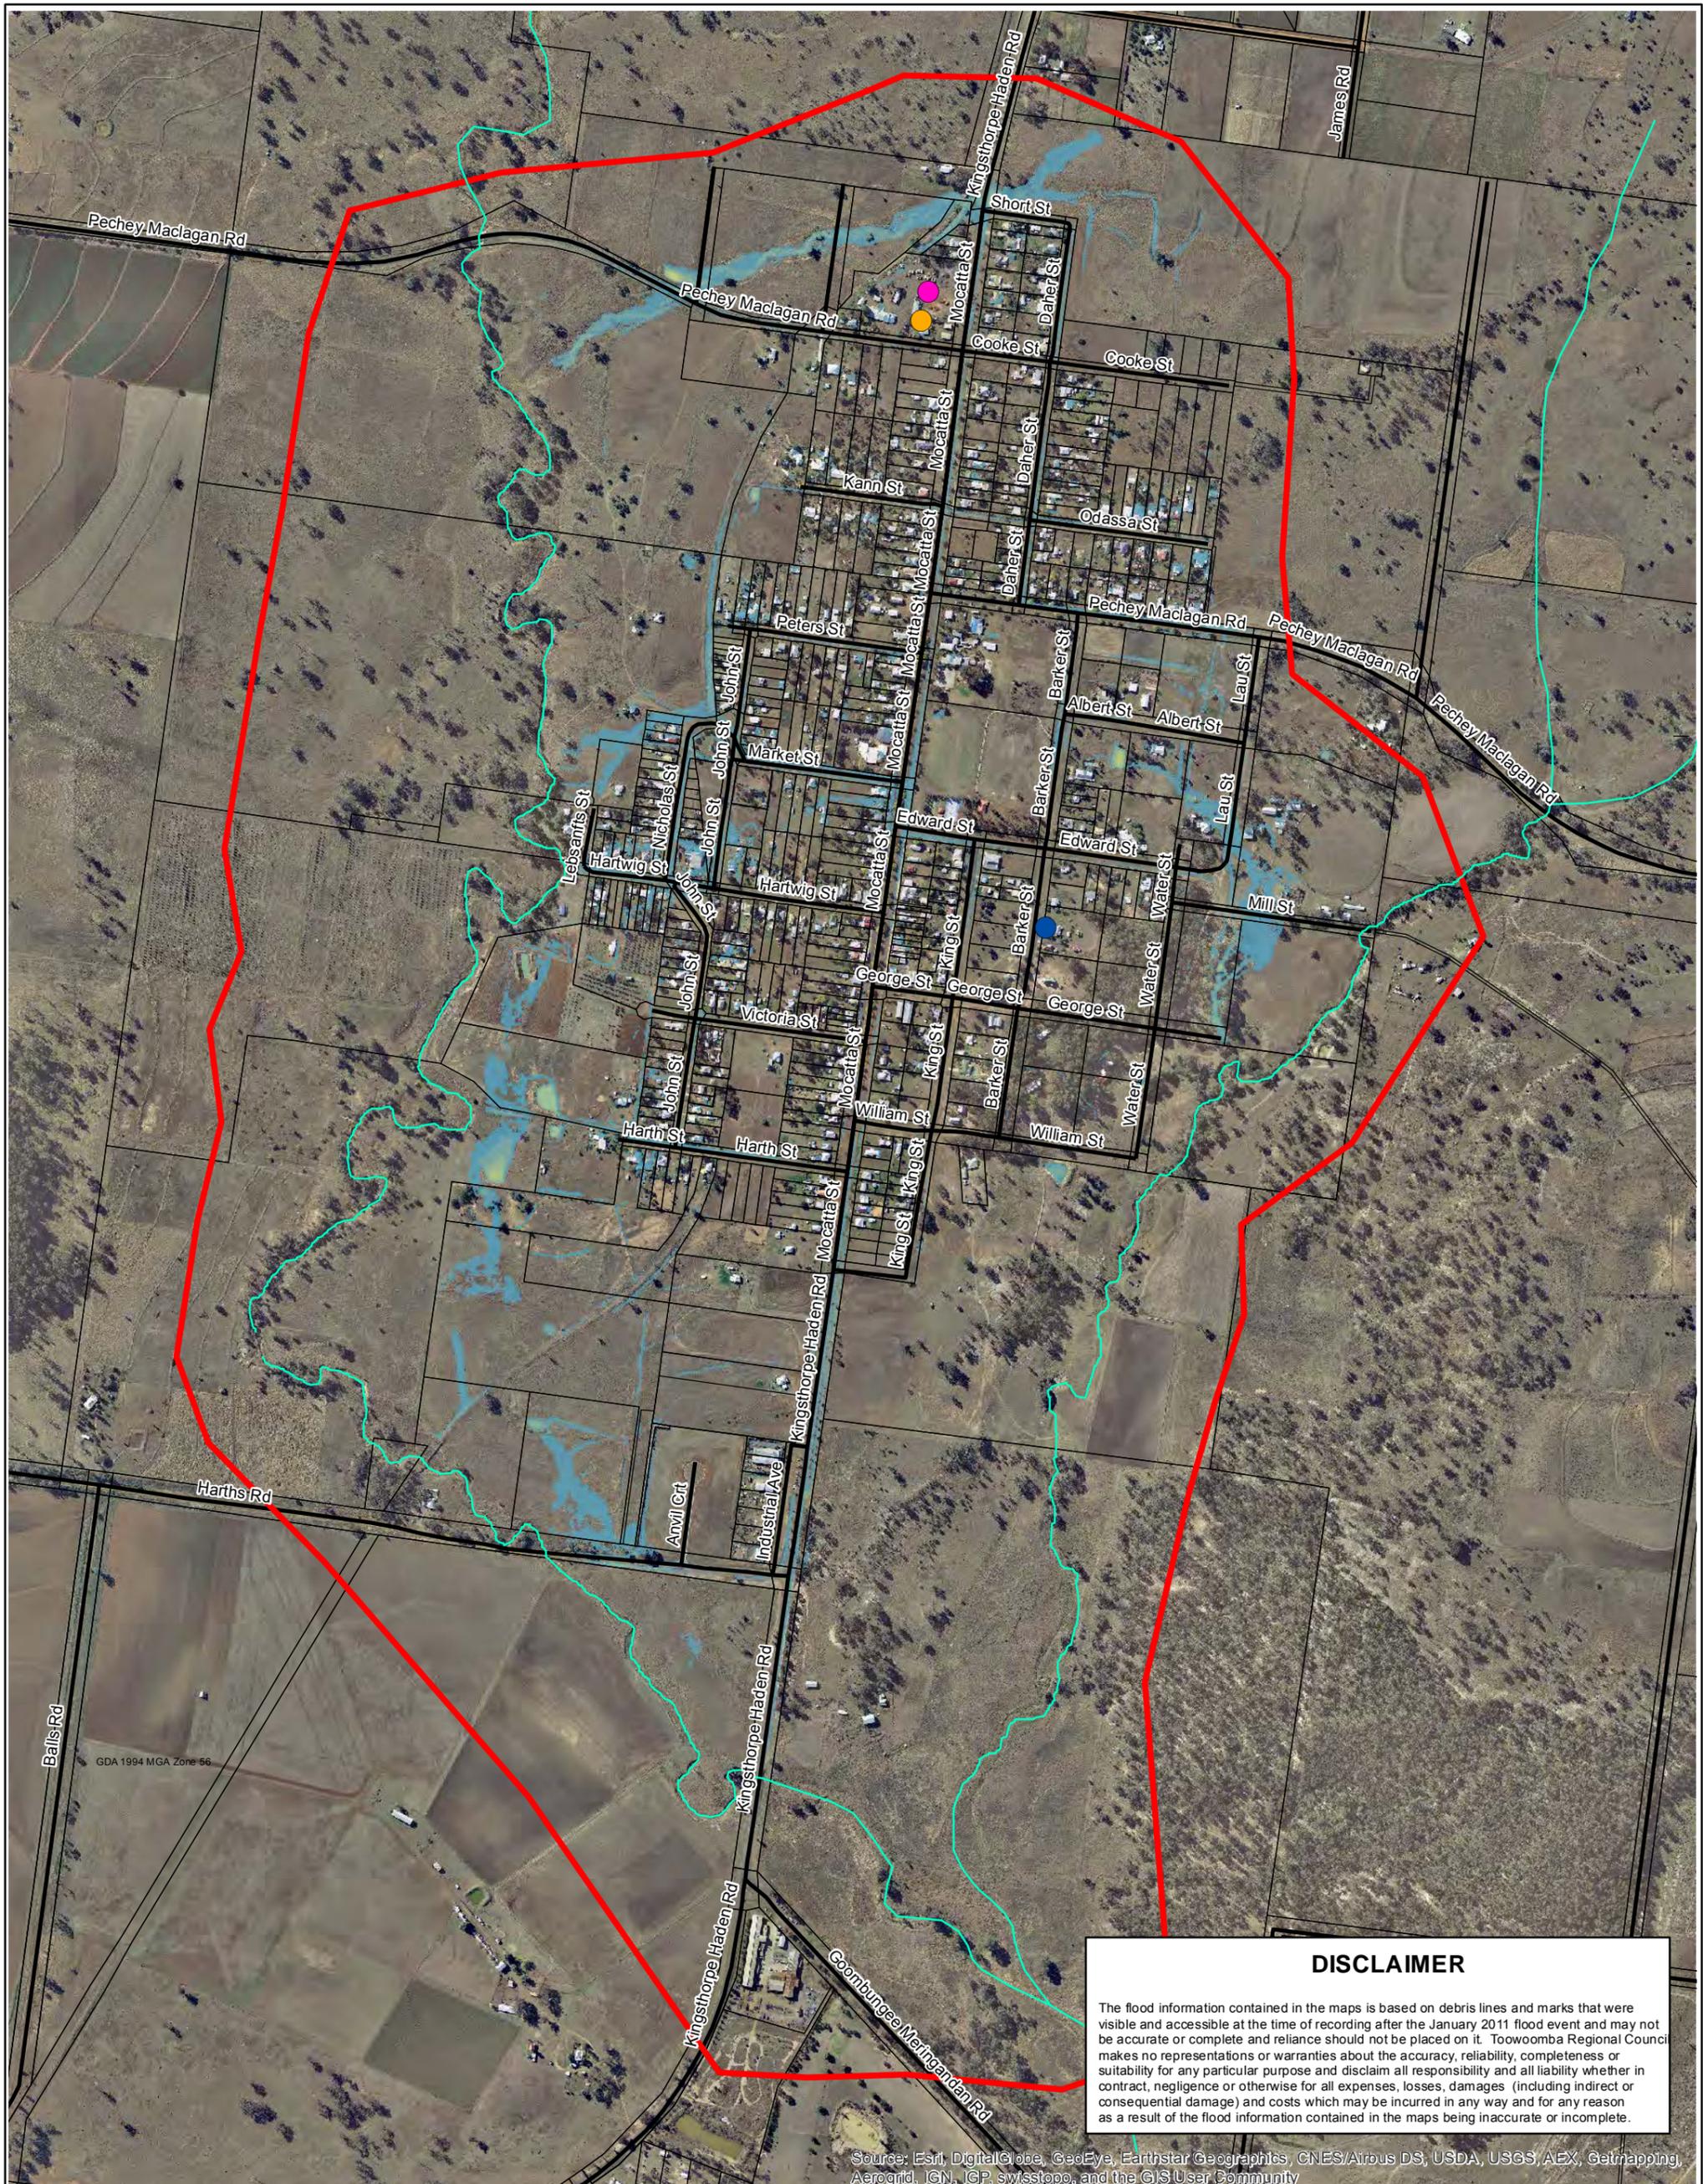
SP051 Flood Studies - Work Package 11
 Goombungee - Riverine Flow
 100 Year ARI Peak Water Surface Level Map

- 0.2m contours (mAH)
- 100yr ARI
